The Effects Of Deep Excavations In Soils And Rock On Adjacent Structures

K.Y. Lo

THE EFFECTS OF DEEP EXCAVATIONS IN SOILS AND ROCK ON ADJACENT STRUCTURES

(The R M Hardy Address)

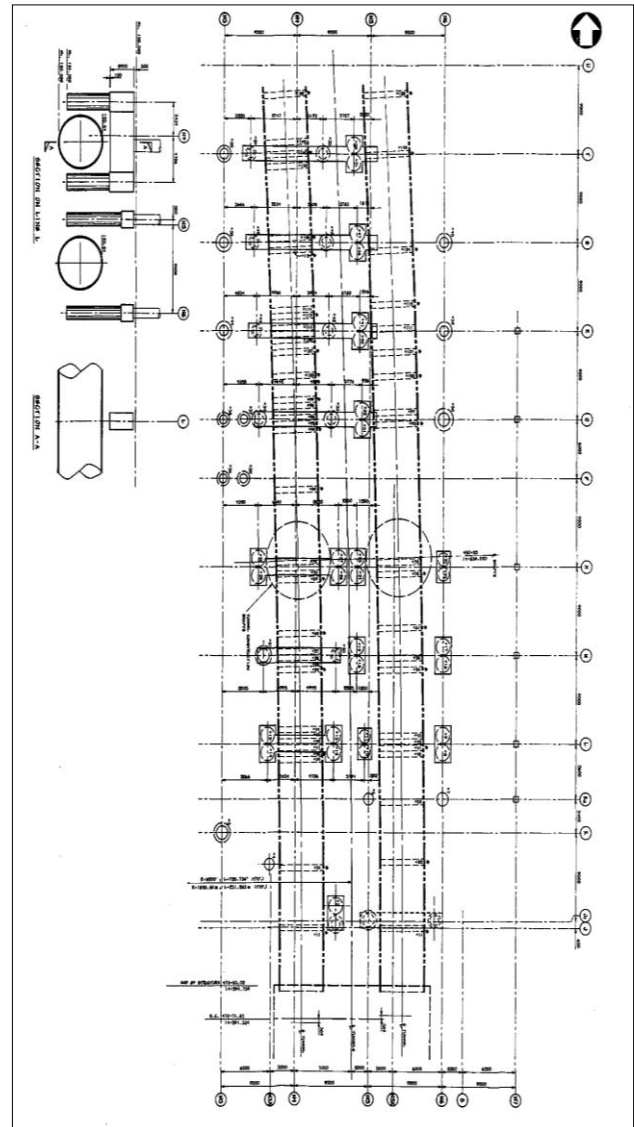
Figure 1 shows the foundation layout over the TTC subway tunnels. To eliminate the net structural loading onto the tunnels the loads were transferred to the subsoil below the invert by caissons of 1.1 to 2.4 m diameters, straddling the tunnels. The design and construction issues were therefore to minimize the effect of excavation for the substructure so as to satisfy the structural and operational requirements of the subway tunnels.

Figure 1. Plan of excavation and foundation layout- York Mills Centre

Complications in analyses and interpretation also arise because excavation was continuing at the south portion (south of column line M in Figure 1) with permission of the engineers, so as not to delay construction. In principle, therefore, for any given profile of final excavation, the predicted displacements (and other relevant quantities) should be considered in the following manner:

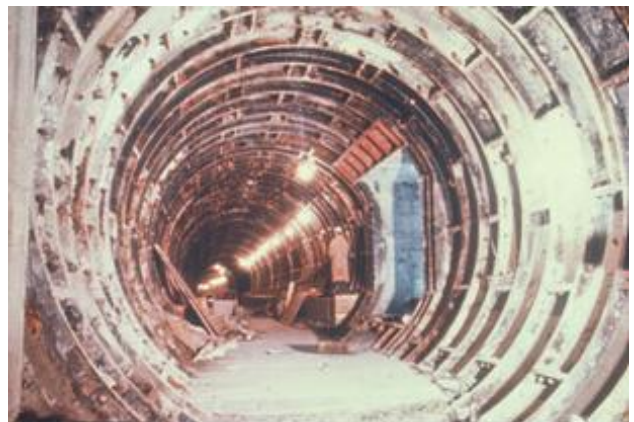
Figure 2. TTC Subway tunnel

The excavation for the substructure was approximately 90 m by 40 m, with depth of excavation generally 7 m to 9 m. The proximity of the general excavation to the tunnel crown was about 2 m. However, local excavation for the load transfer girders was within 0.5 m from the extrados of the lining. A photo of the tunnel is shown in Figure 2. Details of the cast-iron segmental lining are shown in Figure 3. This section of the Yonge Line was constructed in the late 1960s, with cast-iron segmental lining.

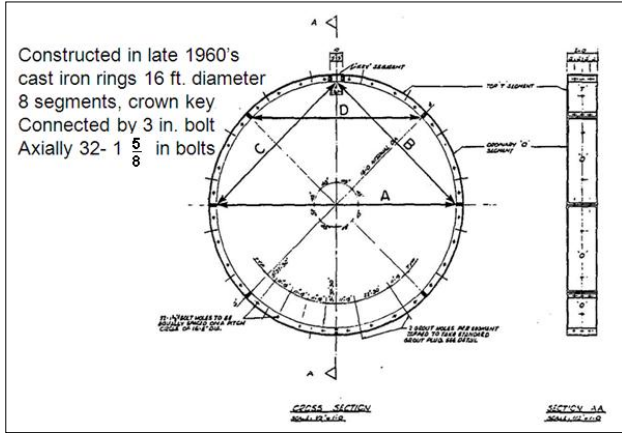
Figure 3. Detail of cast-iron segmental lining of TTC subway

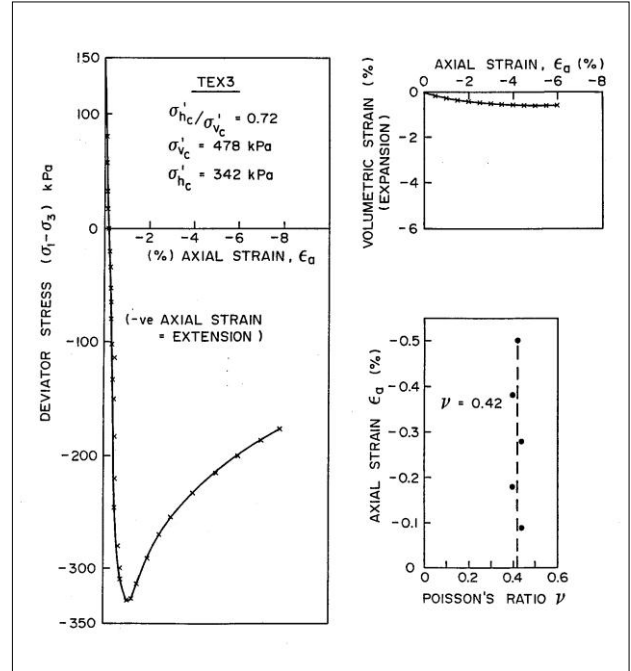
Typical results of a triaxial extension test are shown in Figure 4. It may be seen that the initial portion of the stress-strain curve is linear up to at least 0.4% axial strain. The strain at failure is approximately 1%. The sample dilates during shear but the volumetric strain is small. The Poisson's ratio is 0.42 in this test.

Figure 4. Typical results of anisotropically consolidated drained triaxial extension test

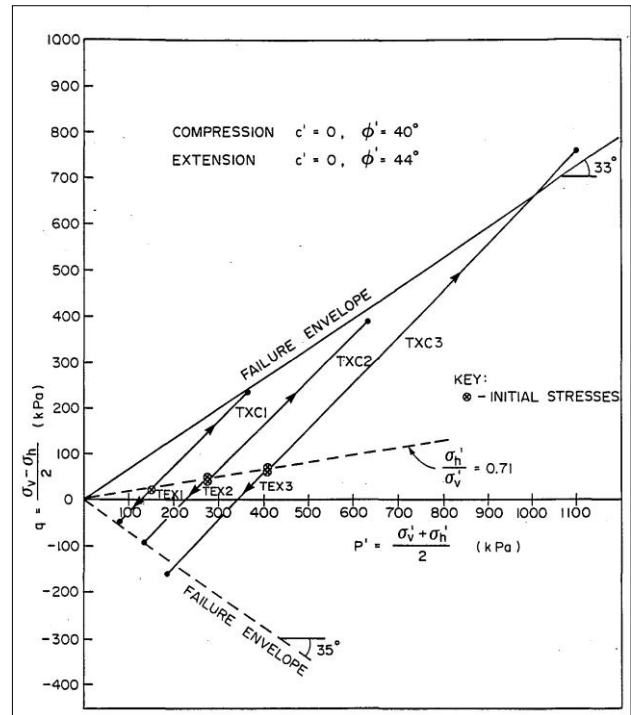
Figure 5. Failure envelope of triaxial compression and extension tests

The strength envelope for the compression and extension tests are shown in Figure 5. The samples were anisotropically-consolidated to an effective stress ratio of

$\sigma'_h / \sigma'_v = 0.7$. For design purpose, the effective stress parameters were taken to be $c' = 0$, $\phi' = 40^\circ$.

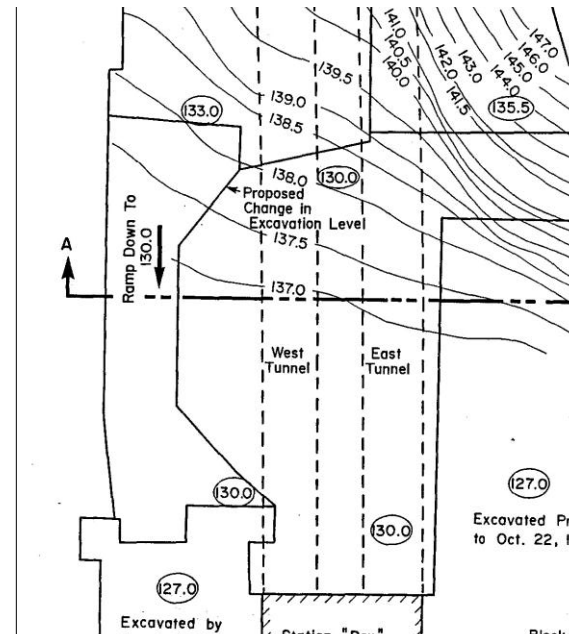
The proposed excavation in plan, as of December 1987, is shown in Figure 6.

Figure 6. Plan showing final excavation levels (proposed as of December 1987)

However, it may be seen from Figure 6 that the critical areas for both transverse and longitudinal analyses are north of column line M, so that items (2) and (3) are almost identical in these areas.

(i) in the transverse direction, a plane strain elastoplastic finite element analyses were performed on the chosen critical section A-A on Figure 6 and is illustrated in Figure 9;

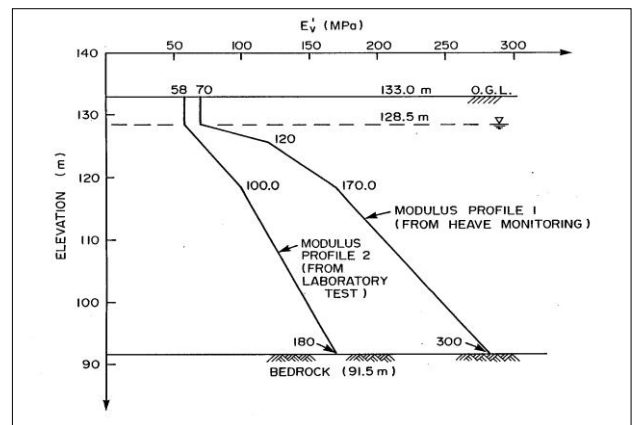
In the second stage, block samples were recovered at the location of the south-east portion of the excavation already completed. Typical results of drained extension tests, shown in Figure 4 were employed to obtain the distribution of modulus with depth. Finally, advantage was taken of the on-going excavation west of the Don Mills subway station (see Figure 6) to install instruments for heave monitoring. At locations P1 and P2, magnetic extensometers were installed and the heaves at six different depths were measured as local excavations were carried out in this area. No de-watering is allowed within the zone of influence of the heave monitoring area, to ensure that the heave measurements were not affected. The results of these measurements are shown in Figure 7.

Figure 7. Distribution of unloading modulus with depth

The soil parameters, based on laboratory test results are shown in Table 1. The two soil deformation modulus profiles in Figure 7 were employed, but design decisions were based on the profile evaluated from heave measurement.

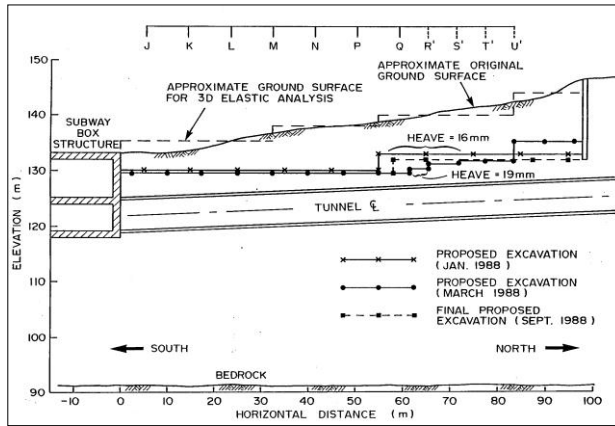
During the course of design, however, the geometry and depths of excavation were changed several times. The final longitudinal section adopted, together with two other proposals analyzed, is shown in Figure 8.

Figure 8. Longitudinal section of proposed excavations along tunnel

The results of analyses indicated that the proposed excavation with the final profile shown in Figure 8 was technically feasible without causing undue distress to the lining and it was decided that the construction would go ahead with a monitoring program to verify the design assumptions and construction control.

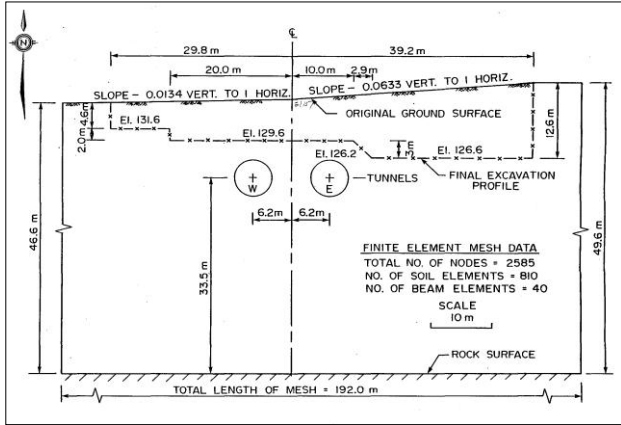
Figure 9. Condition modelled in transverse finite element analysis

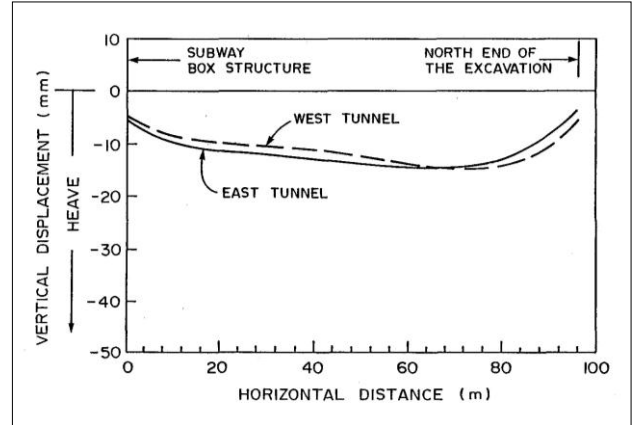
Figure 12. Predicted displacement profile of east and west tunnels after general excavation

The predicted longitudinal deflection of the east and west tunnels at different stages are shown in Figure 10 to Figure 12. Further details of analysis and interpretation of analysis results may be found in Lo and Ramsay (1991).

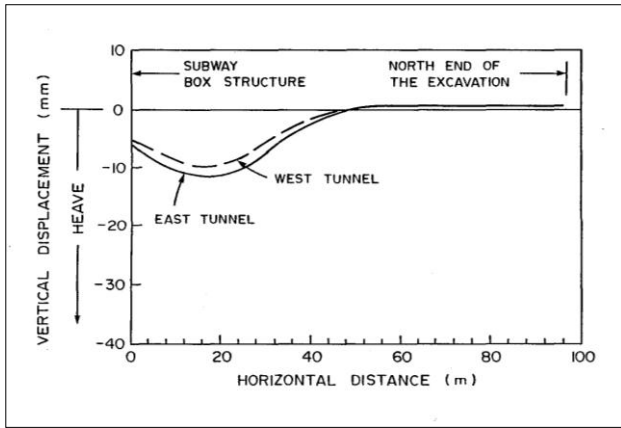
Figure 10. Predicted displacement profiles of the east and west tunnel for the area excavated prior to December 1, 1987 – prior to monitoring

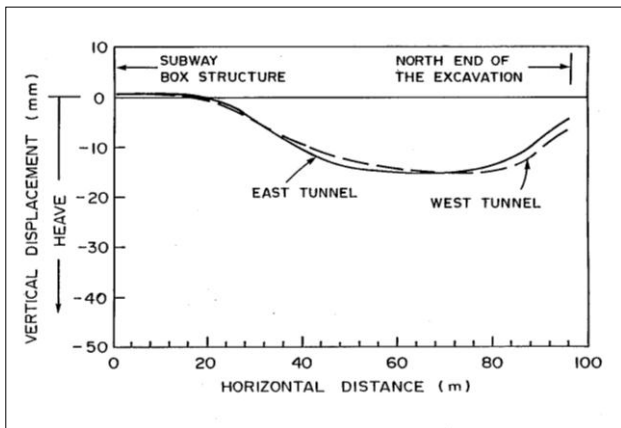
Figure 11. Predicted additional displacements along the east and west tunnels due to proposed additional excavation

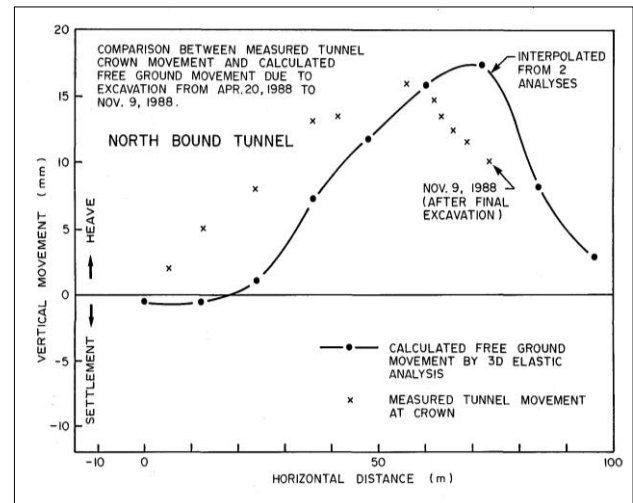
In the longitudinal direction, the deflections predicted for the northbound and southbound tunnels are compared with results of monitoring in Figure 13 and Figure 14 respectively. It can be seen that the maximum heaves measured were slightly below those predicted for both tunnels. It may be observed that the design criterion for heave was satisfied.

Figure 13. Comparison between predicted and measured heaves – northbound tunnel

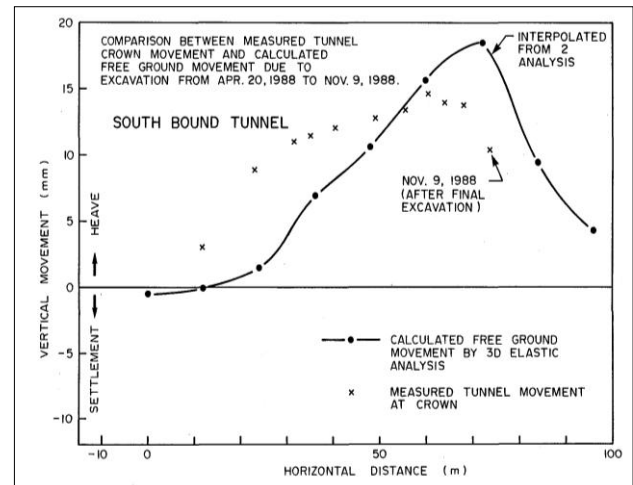
Figure 14. Comparison between predicted and measured heaves – southbound tunnel

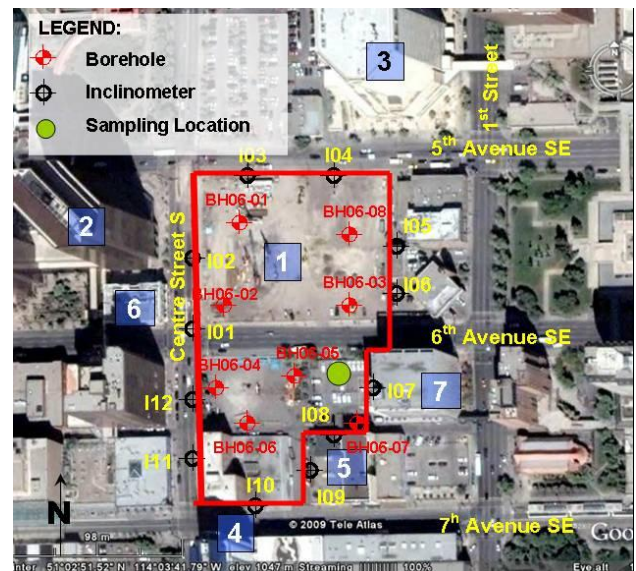
The excavation for the construction of the Bow office tower involved two city blocks. It covers a footprint of 17,000 m², 190 m long, 100 m wide and 21 m deep. It covers a footprint of 17,000 m², 190 m long, 100 m wide and 21 m deep. As shown in Figure 15, a number of

structures exist at close proximity to the excavation. These structures include the Telus building in the north, the Calgary Light Rail Transit in the south, the Petro-Canada Centre in the west, the Andrew Davidson building and the historic Royal Canadian Legion No. 1 building in the south-east side.

Figure 15. The Bow site: (1) The Bow; (2) Petro-Canada Centre; (3) Telus; (4) Calgary's Light Rail Transit; (5) The Royal Canadian Legion No. 1; (6) Chamber of Commerce and (7) Andrew Davidson Building (modified from Lo et al. 2009)

To obtain the required strength and deformation parameters, block samples were recovered from the bottom of the excavation at the location shown in Figure 15. The highly fissile nature of the mudstone rendered both sampling and preparation of specimen for triaxial and shear box tests very difficult. Nonetheless, adequate test results were obtained for the on-going analysis and excavation process.

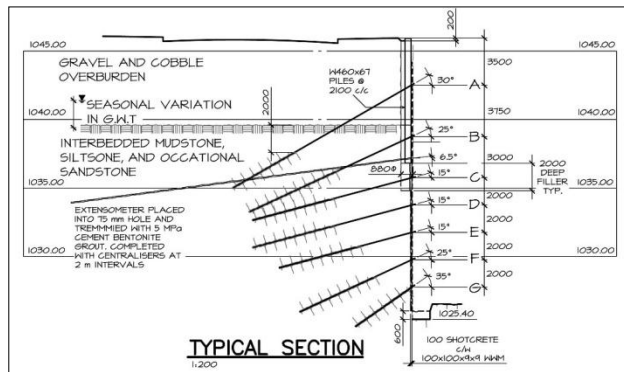
Figure 16. The Bow excavation –typical section

The caisson wall was 800 mm in diameter interlocking with soldier piles set between two filler piles. The general arrangements of the anchors are shown in Figure 16. Details of the anchor capacities are shown in Table 6. It should be noted anchors were added whenever required during construction when impending problems became evident.

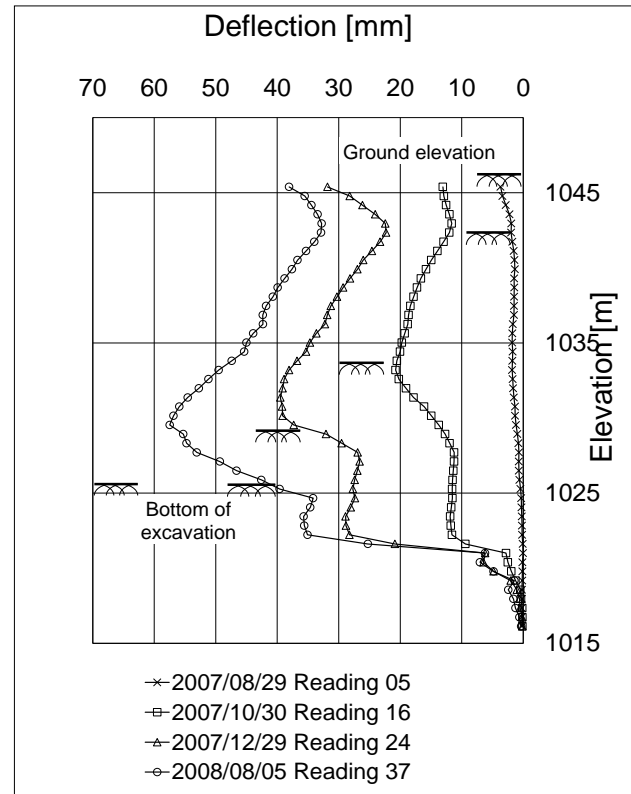
As excavation proceeded and results of monitoring became available, it became evident that potential threat of excessive deformation exists. Figure 17 shows that even though the excavation was only 12 m deep and was 6 m into rock and 14 m above the shear band, the displacement at the shear band had already been triggered resulting in a displacement of 10 mm. It was therefore necessary to define the uncertainties involved in the design problem and address these issues so that construction may proceed with a better understanding of the rock behaviour for construction control.

Figure 17. Inclinator 4 Readings

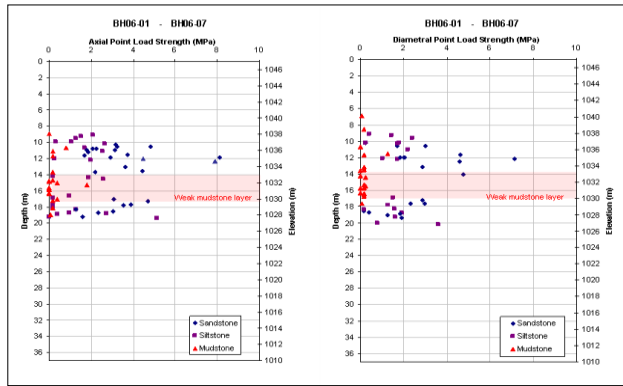
Figure 18. Point load strength profile

A detailed review of geotechnical site investigation report was performed. A summary plot of all the point load test results from BH06-01 to BH06-07 in both the axial and diametral directions are shown in Figure 18. It can be seen from the results of diametral point load test that there is a clear demarcation of a weak zone of mudstone exist within the depths of 13.5 m to 17 m across the area of the excavation. The results of axial tests did not give a distinct trend. The difference in behaviour is due to the layered nature of the rock. Failure in the axial direction tends to involve more than one layer while failure in the diametral direction tends to be tensile fractures in the weak mudstone. It will be shown that this weak zone correlates well with results of inclinometer monitoring. It also played a major role in contributing to some significant movements to the surrounding structures.

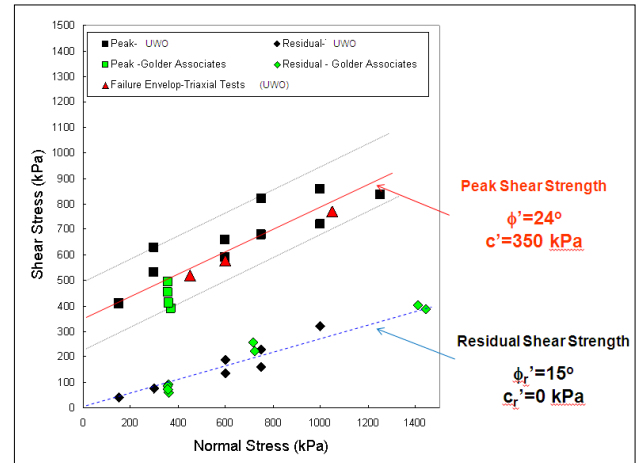
The results of shear box and triaxial tests are shown in Figure 19. To verify the reliability of test results, tests were performed at two laboratories. It can be seen that the results were quite consistent, yielding peak strength parameters of $c' = 0.35$ MPa and $\phi = 24^\circ$ and residual parameters $c_r' = 0$ MPa and $\phi_r' = 15^\circ$. Further details of test results and deformation parameters obtained therefrom may be found in Lo et al (2009). The engineering parameters employed in numerical analysis for each rock unit are summarized in Figure 20.

Figure 19. Multistage direct shear test results

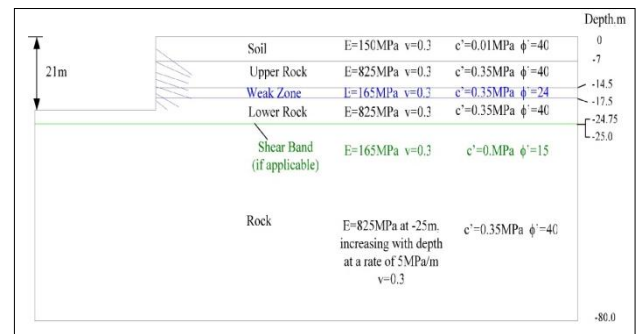
Figure 20. Engineering Parameters

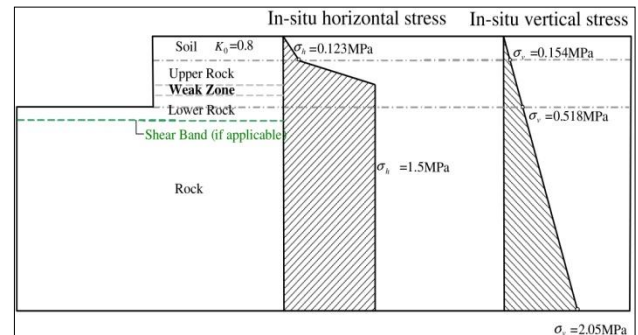
It appears that no in situ rock stress measurements have been carried out in the near surface rock formations in the Calgary area. Therefore, the magnitudes and directions of the in situ horizontal stresses which provide the driving force in rock deformation are not known. Based on experience of stress measurements in weak rock formation elsewhere, it was assumed that the magnitude of the horizontal stress may lie between 1 to 2 MPa. The distribution of assumed horizontal stress is shown in Figure 21, together with the vertical stress distribution based on overburden weight.

Figure 21. Assumed vertical and lateral *in-situ* stresses

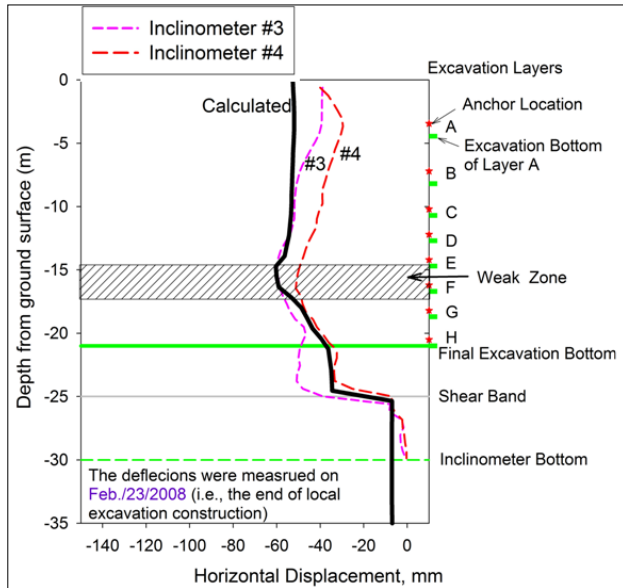
Figure 22. Calculated and measured deflections- North wall

The results of analysis at the north wall are compared with the results of monitoring from inclinometers No. 3 and No. 4 as shown in Figure 22.

The measured displacements from the two inclinometers are quite comparable and exhibit the same characteristics in the distribution of movements with depth. The calculated displacements show the same features. In particular, the following characteristics of movements may be observed.

- (i) The shear band induced an abrupt displacement of about 30 mm at a depth of 4 m below the bottom of the excavation.
- (ii) The weak zone between 14.5 m to 17.5 m depth caused a bulging effect at its corresponding elevations consistent with the results of diametral point load tests shown in Figure 18.
- (iii) The magnitude and depth of maximum lateral movement (60 mm) from monitoring and computations are consistent. The pattern of deformation behind the excavation is shown in Figure 23.

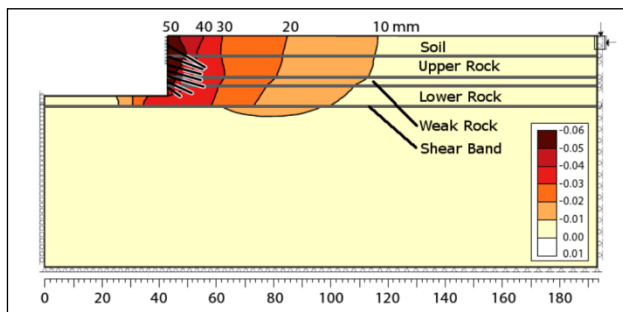
Figure 23. Computed horizontal displacements- North wall

It is significant to note that the displacement contours show a clear discontinuity at the shear band, indicating interface slip. This interface slip resulted in substantial lateral displacements far away from the excavation face as shown in the figure. Thus, at a distance approximately 4 times the depth of the excavation, the horizontal displacement is still as much as 10 mm.

The maximum calculated settlement is 13.3 mm at a distance of about 10 m from the north wall. The maximum base heave is 28 mm at a distance of about 12 m from the excavation face. While no precise measurements were made with regard to these quantities, general observations at the site are quantitatively consistent with the estimates.

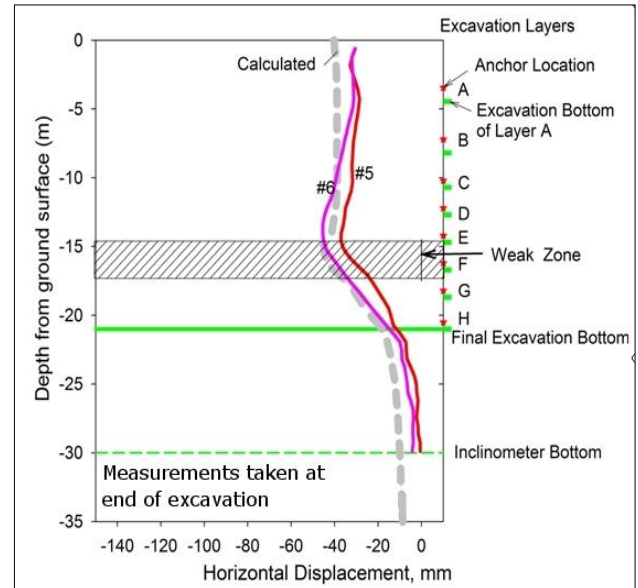
Figure 24. Calculated and measured deflections – East wall

two inclinometers quite satisfactorily both in magnitude and distribution.

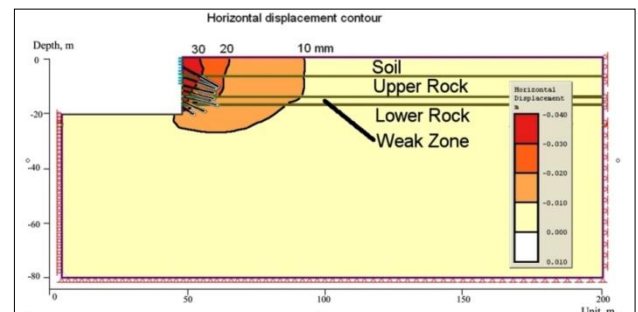
Figure 25. Computed horizontal displacement – East wall

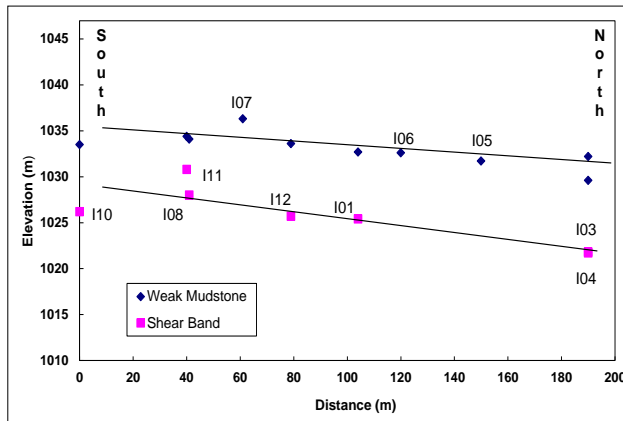
From results of inclinometer monitoring, it is possible to identify the occurrence and location of the weak zone and shear band across the site. The results are shown in Figure 26. It is noted that the weak zone was present at all locations monitored by the inclinometers.

Figure 26. Inclination of the weak zone and shear band across the site

The shear band, however, was not exhibited at locations of I05, I06 and I09. It is also interesting to note that both the shear band and weak zone have apparent movement towards the Bow River in the north.

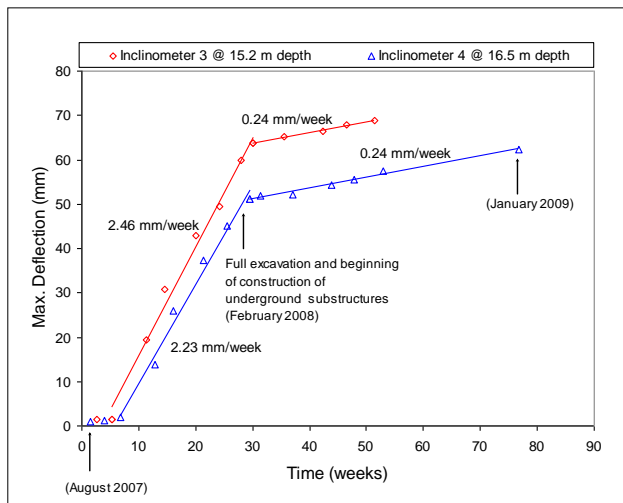
Figure 27. Maximum deflection vs. time inclinometers at the north wall of the Bow excavation
